## Windstorm Mitigation Report (OIR-B1-1802)

Eastwood Shores Condominium No. 4 Association, Inc.

1837 Bough Ave, Units A-D

As of 9/7/2023 | FPAT File# MIT2218498

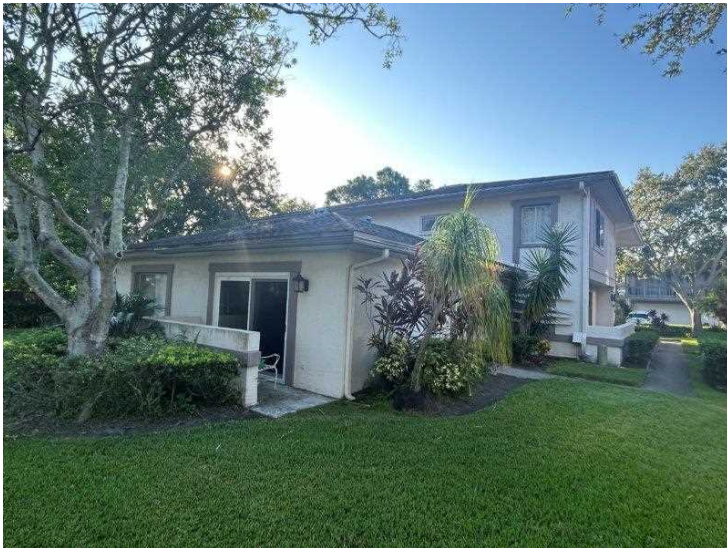
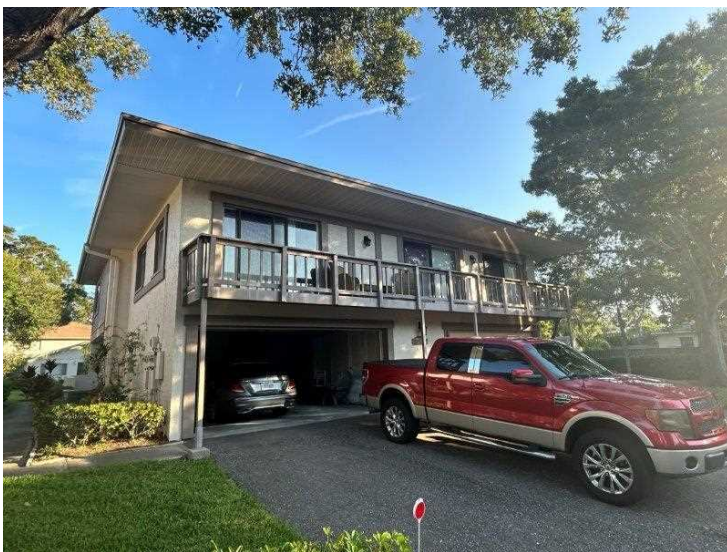
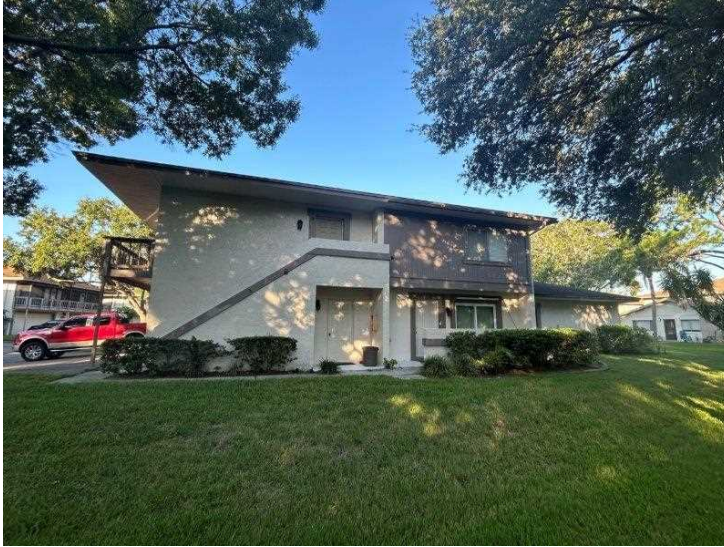
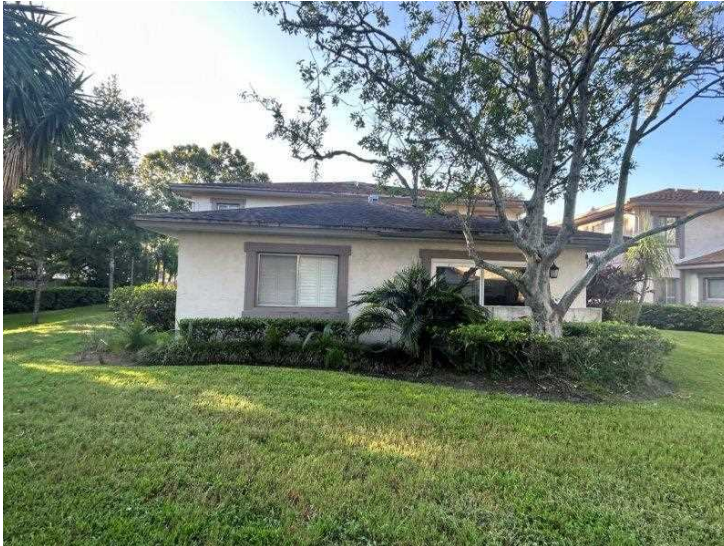
Exterior Elevation

- 4. Roof to Wall Attachment:** **Toe Nails**  
Comments: Inspection verified embedded straps fastened with less than three nails.
- 5. Roof Geometry:** **Hip Roof**  
Comments: Inspection verified a hip roof shape.

- 6. SWR:** **No**  
Comments: At the time of inspection, no SWR was verified.
- 7. Opening Protection:** **None or Some Glazed Openings**  
Comments: No opening protection verified at the time of inspection.

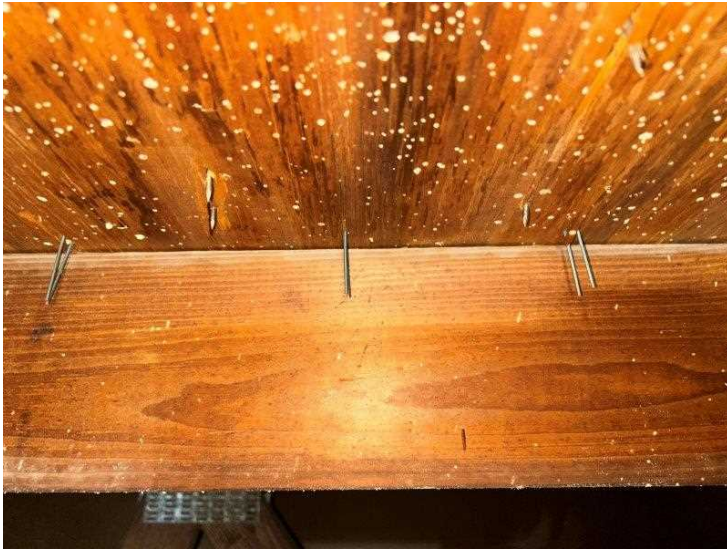
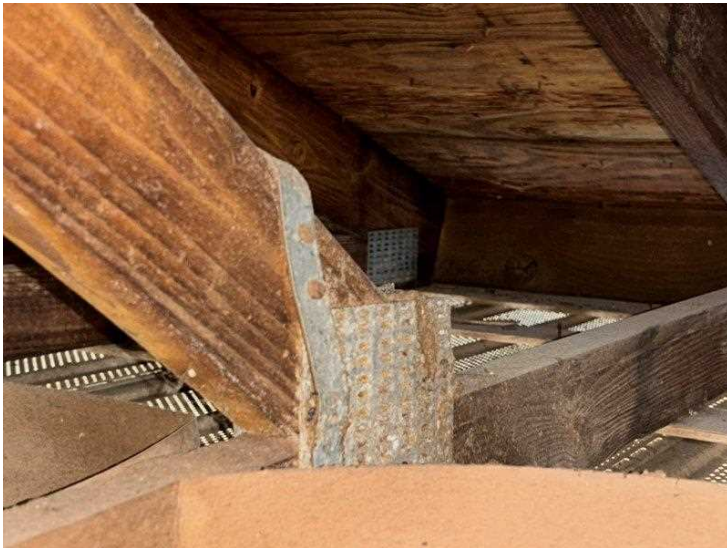
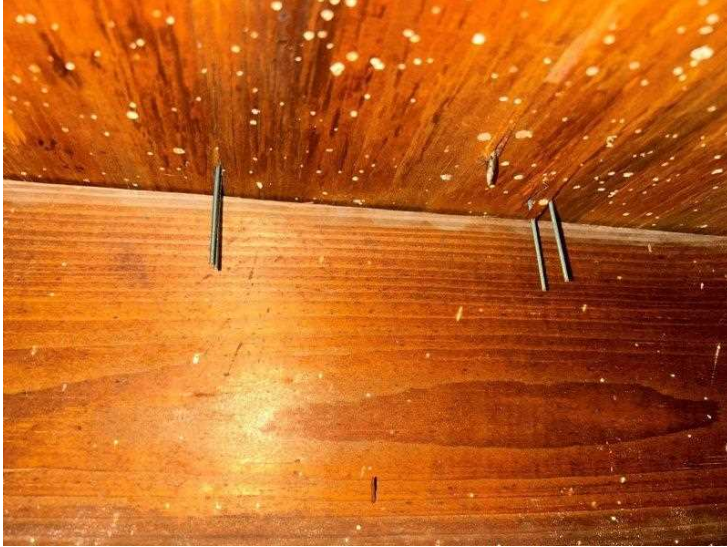
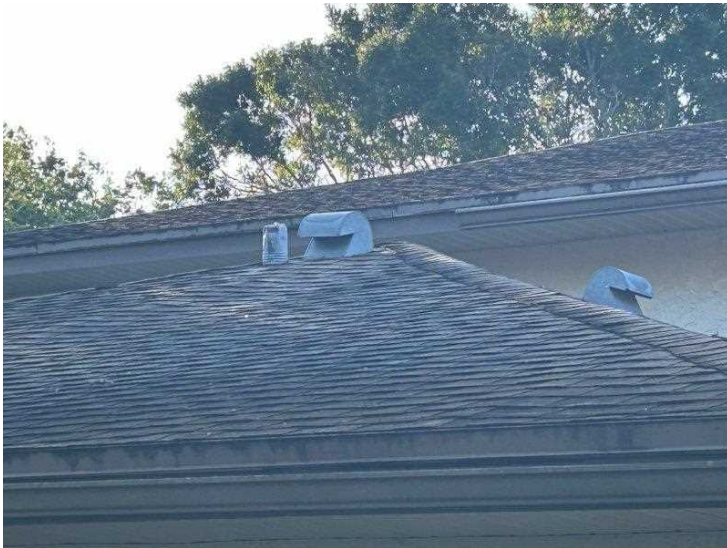
Roof Construction

- 3. Roof Deck Attachment:** **Level A**  
Comments: Inspection verified 1/2" plywood roof deck attached with staples at a minimum of 6" on the edge & 12" in the field.
