Windstorm Mitigation Report (OIR-B1-1802)

Eastwood Shores Condominium No. 4 Association, Inc.

1841 Bough Ave, Units A-D

As of 9/7/2023 | FPAT File# MIT2218498

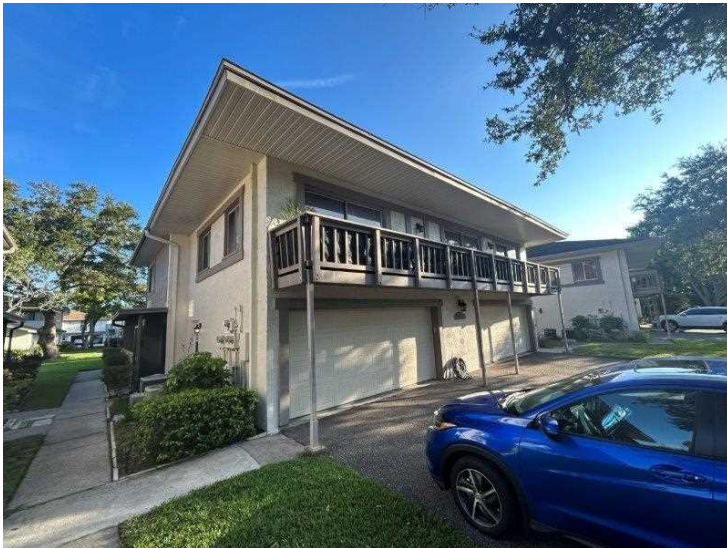
Exterior Elevation

- 4. Roof to Wall Attachment:** **Clips**
Comments: Inspection verified embedded straps fastened with a minimum of three nails.
- 5. Roof Geometry:** **Hip Roof**
Comments: Inspection verified a hip roof shape.

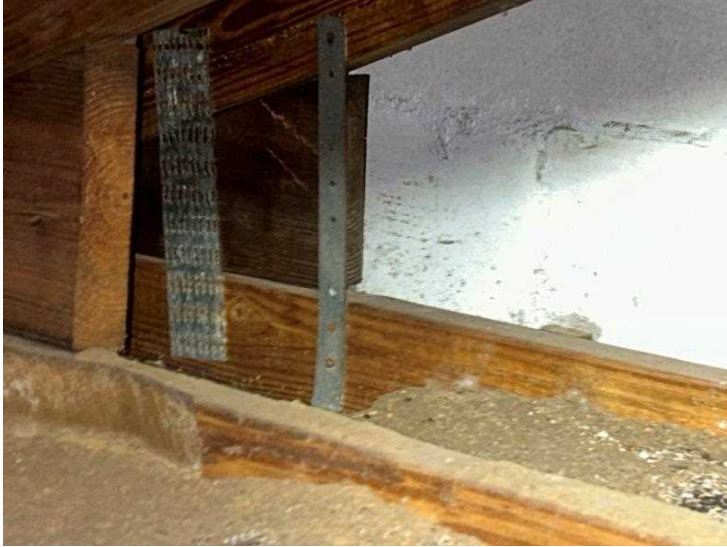
Roof Construction

- 3. Roof Deck Attachment:** **Level A**
Comments: Inspection verified 1/2" plywood roof deck attached with 6d nails at a minimum of 6" on the edge & 12" in the field.

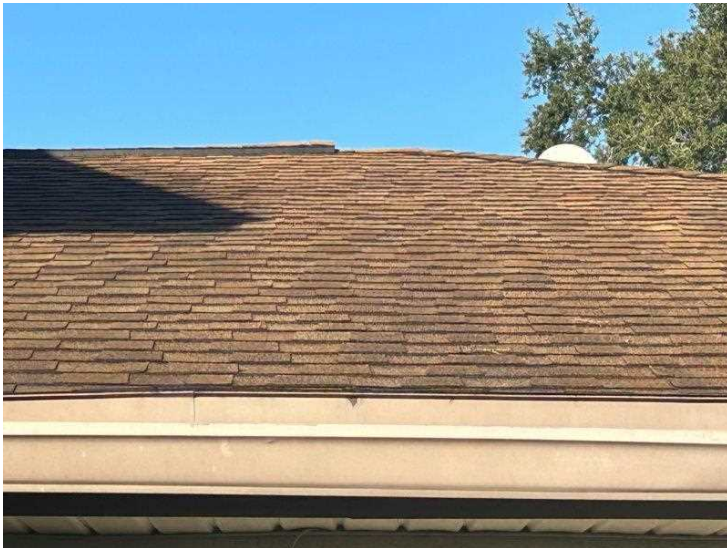
Roof Construction

- 6. SWR:** **No**
Comments: At the time of inspection, no SWR was verified.
- 7. Opening Protection:** **None or Some Glazed Openings**
Comments: No opening protection verified at the time of inspection.
