## Windstorm Mitigation Report (OIR-B1-1802)

Eastwood Shores Condominium No. 4 Association, Inc.

1843 Bough Ave, Units A-D

As of 9/7/2023 | FPAT File# MIT2218498

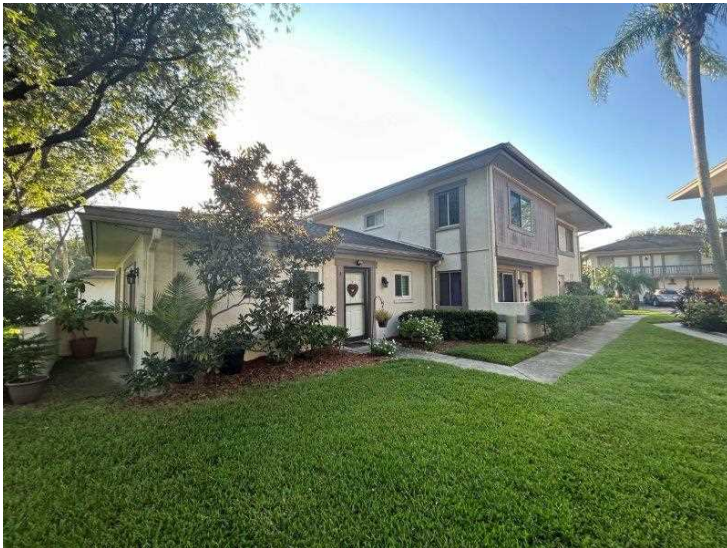
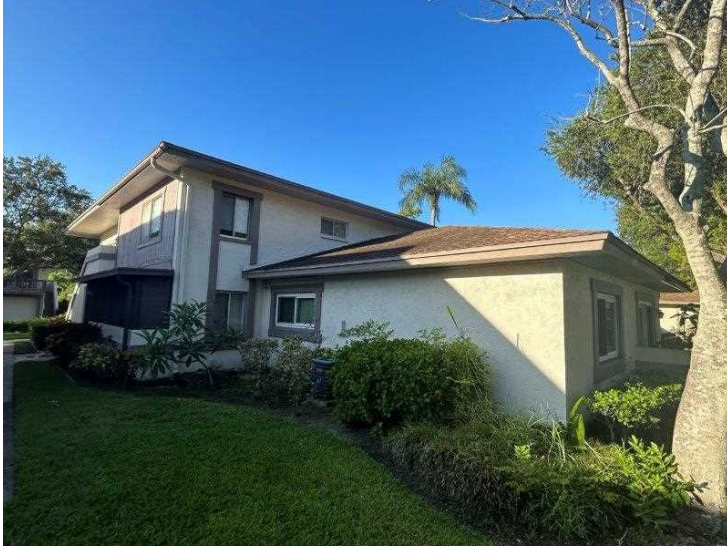
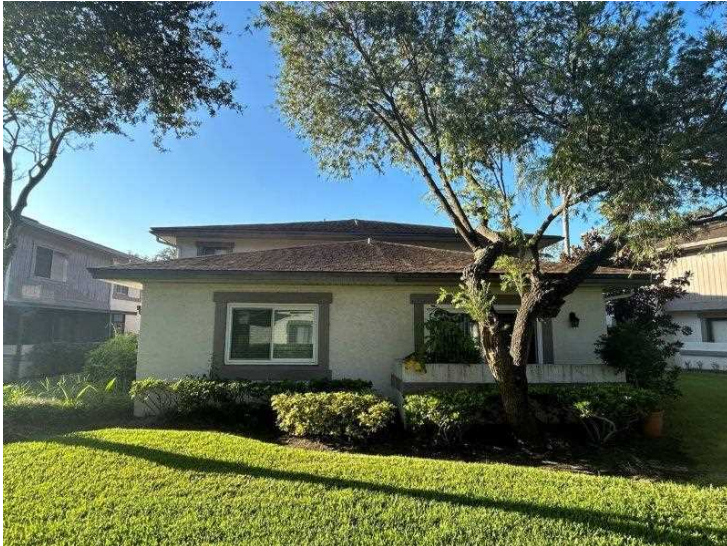
Exterior Elevation

- 5. Roof Geometry:** **Hip Roof**  
Comments: Inspection verified a hip roof shape.
- 6. SWR:** **No**  
Comments: At the time of inspection, no SWR was verified.

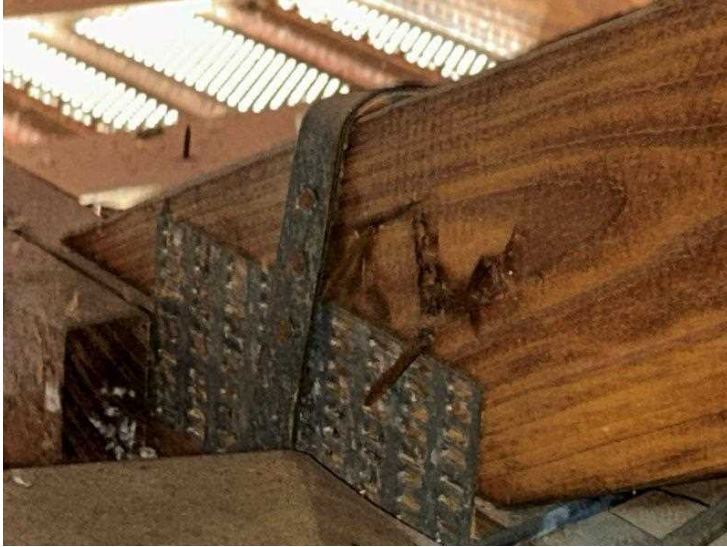
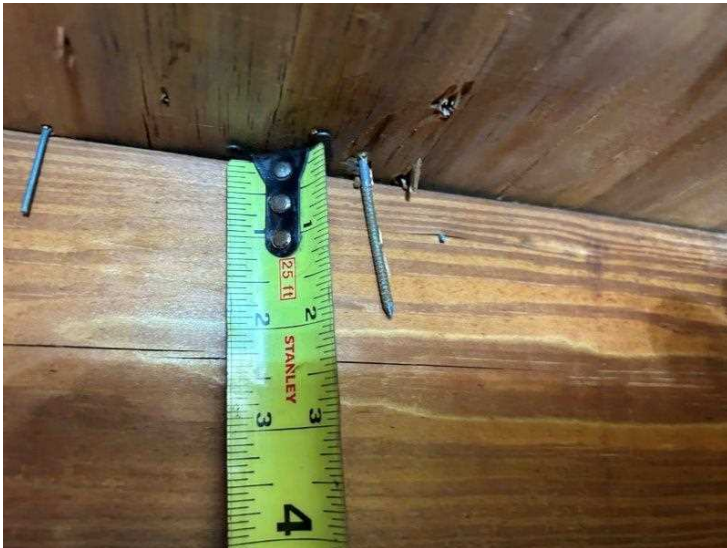
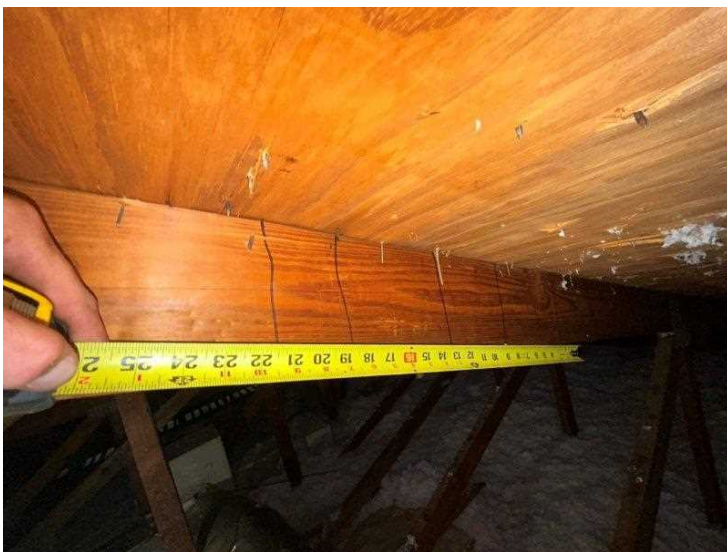
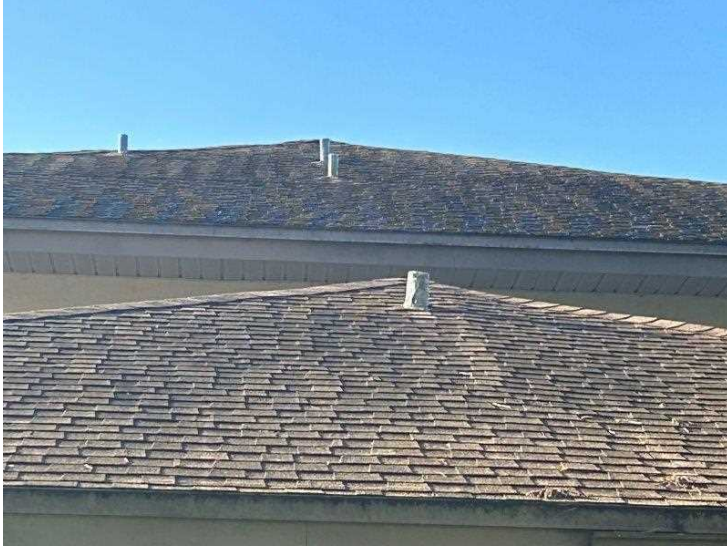
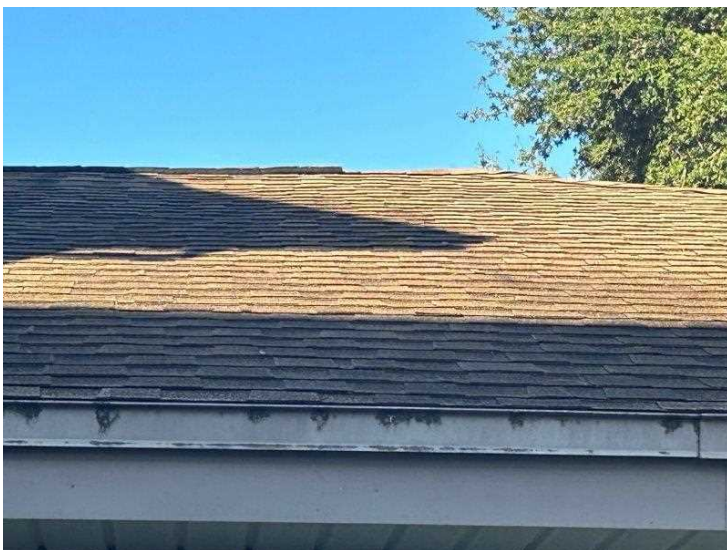
Roof Construction

- 3. Roof Deck Attachment:** **Level C**  
Comments: Inspection verified 1/2" plywood roof deck attached with 8d nails at a minimum 6" on the edge & 6" in the field.

- 4. Roof to Wall Attachment:** **Single Wraps**  
Comments: Single wraps were verified during our attic inspection as the roof wall connection. Each single wrap has a minimum of two nails on the front of the truss and one nail on the opposite side.
