## Windstorm Mitigation Report (OIR-B1-1802)

Eastwood Shores Condominium No. 4 Association, Inc.

1845 Bough Ave, Units A-D

As of 9/7/2023 | FPAT File# MIT2218498

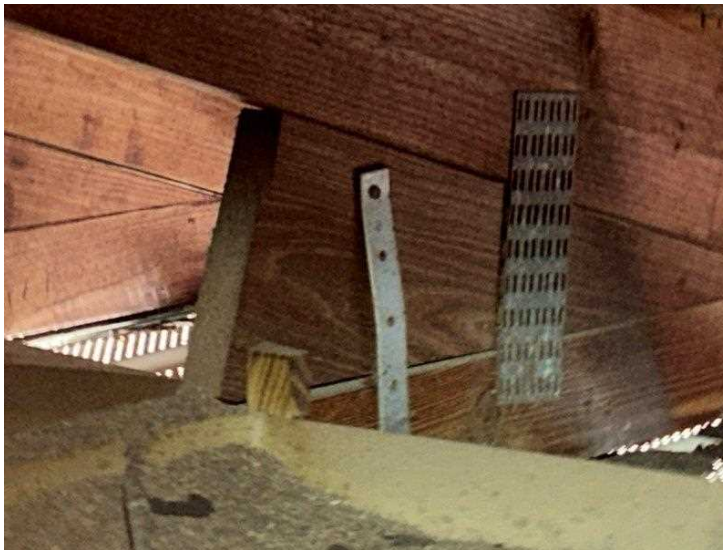
Roof Construction

- 3. Roof Deck Attachment:** **Level C**  
Comments: Inspection verified 1/2" plywood roof deck attached with 8d nails at a minimum 6" on the edge & 6" in the field.

- 4. Roof to Wall Attachment:** **Toe Nails**  
Comments: Inspection verified embedded straps fastened with less than three nails.
- 5. Roof Geometry:** **Hip Roof**  
Comments: Inspection verified a hip roof shape.
