Windstorm Mitigation Report (OIR-B1-1802)

Eastwood Shores Condominium No. 4 Association, Inc.

1847 Bough Ave, Units A-D

As of 9/7/2023 | FPAT File# MIT2218498

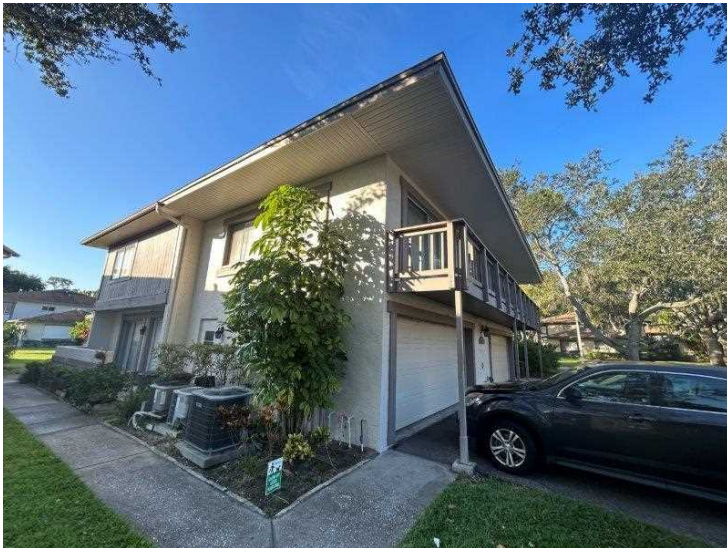
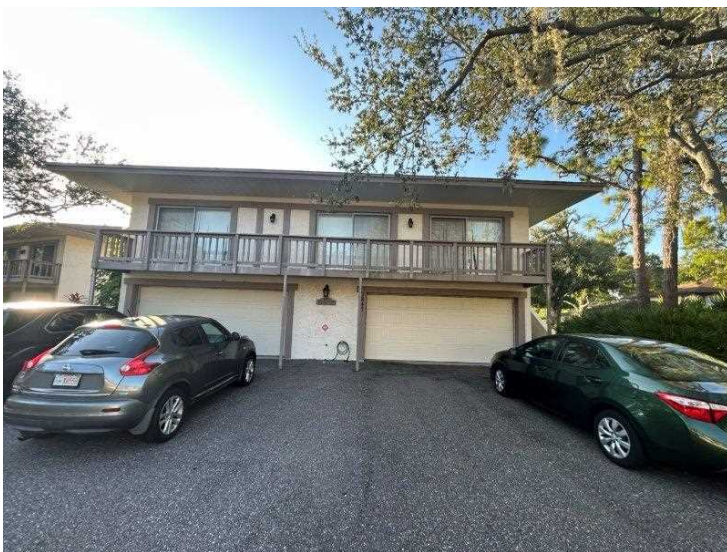
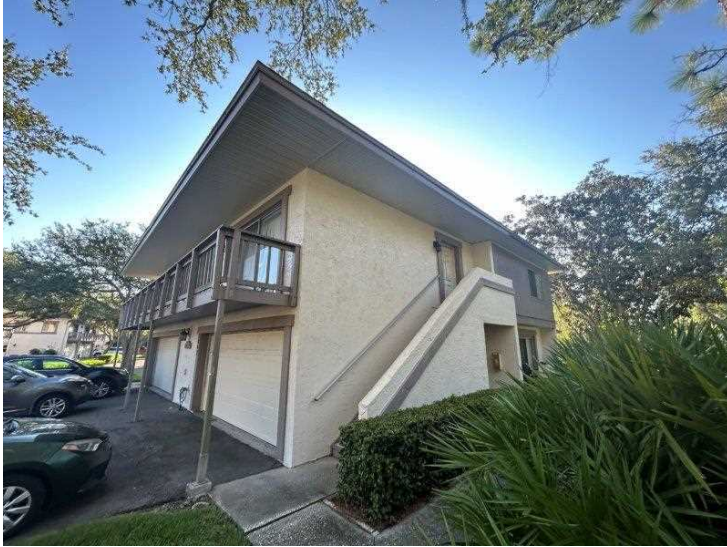
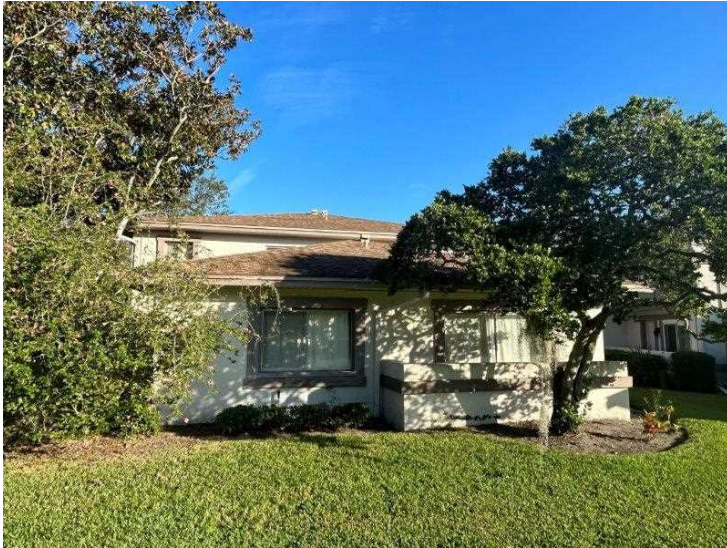
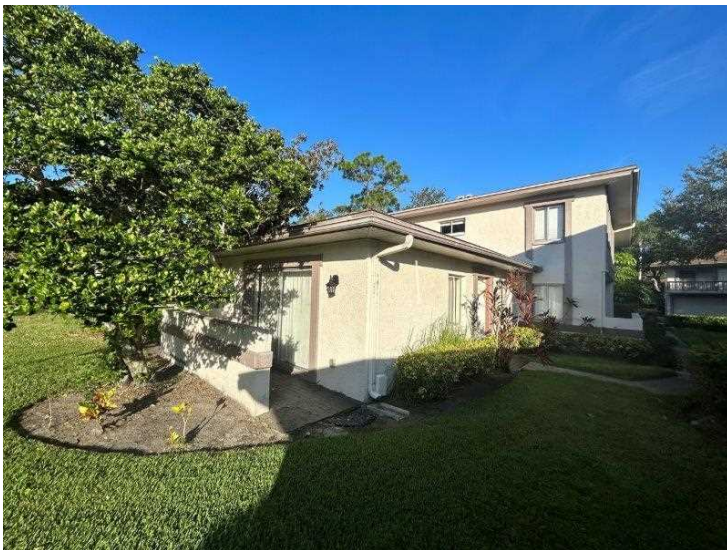
Exterior Elevation

- 4. Roof to Wall Attachment:** **Toe Nails**
Comments: Inspection verified embedded straps fastened with less than three nails.
- 5. Roof Geometry:** **Hip Roof**
Comments: Inspection verified a hip roof shape.

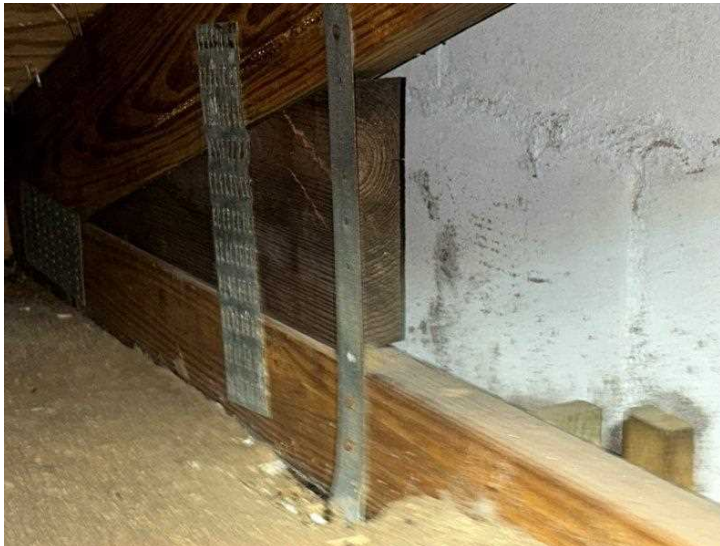
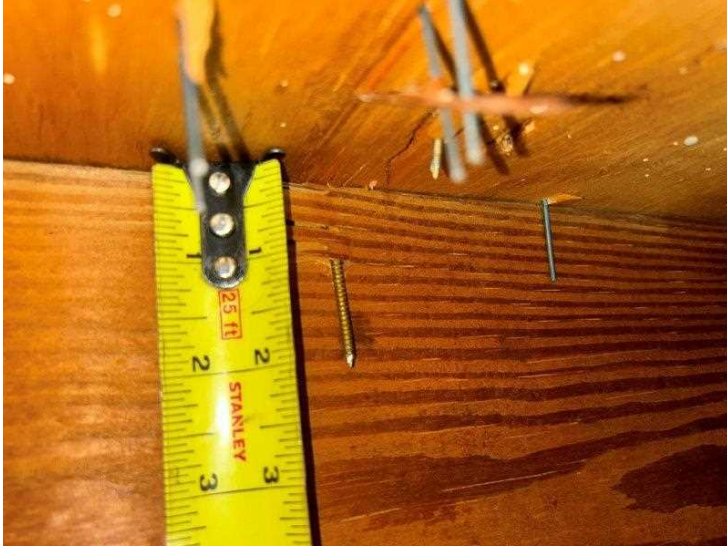
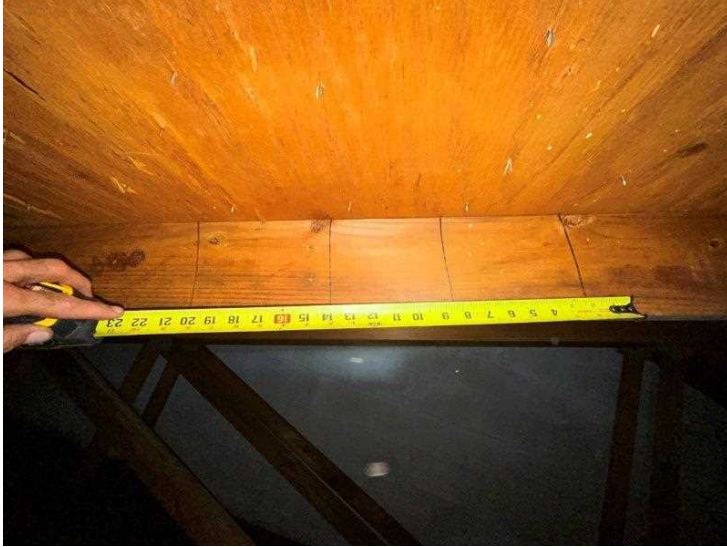
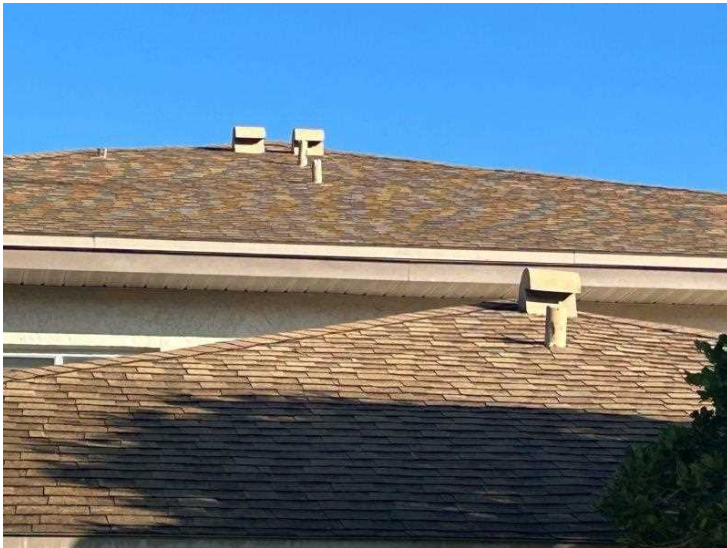
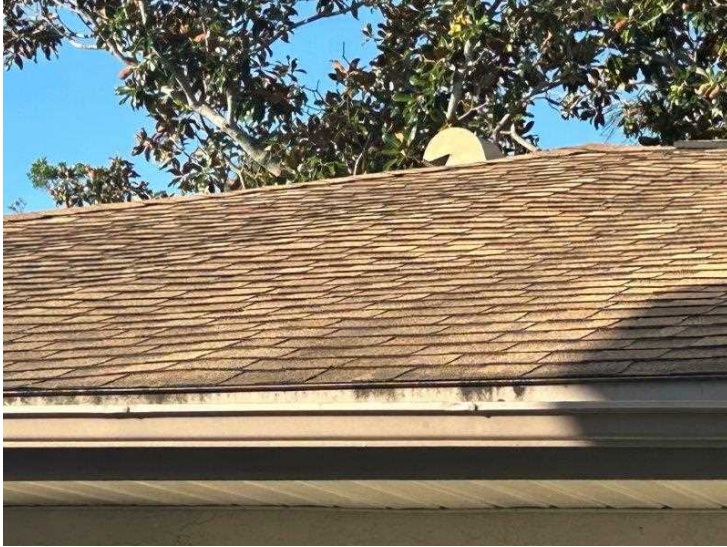
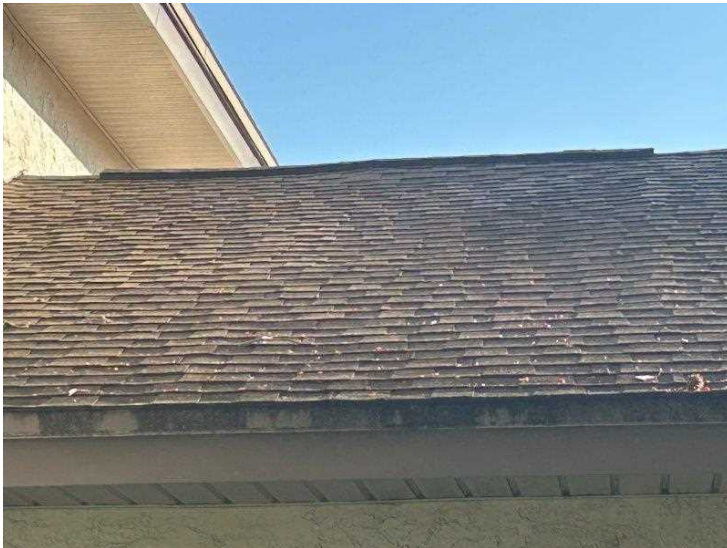
Roof Construction

- 3. Roof Deck Attachment:** **Level C**
Comments: Inspection verified 1/2" plywood roof deck attached with 8d nails at a minimum 6" on the edge & 6" in the field.
