## Windstorm Mitigation Report (OIR-B1-1802)

Eastwood Shores Condominium No. 4 Association, Inc.

1849 Bough Ave, Units A-D

As of 9/7/2023 | FPAT File# MIT2218498

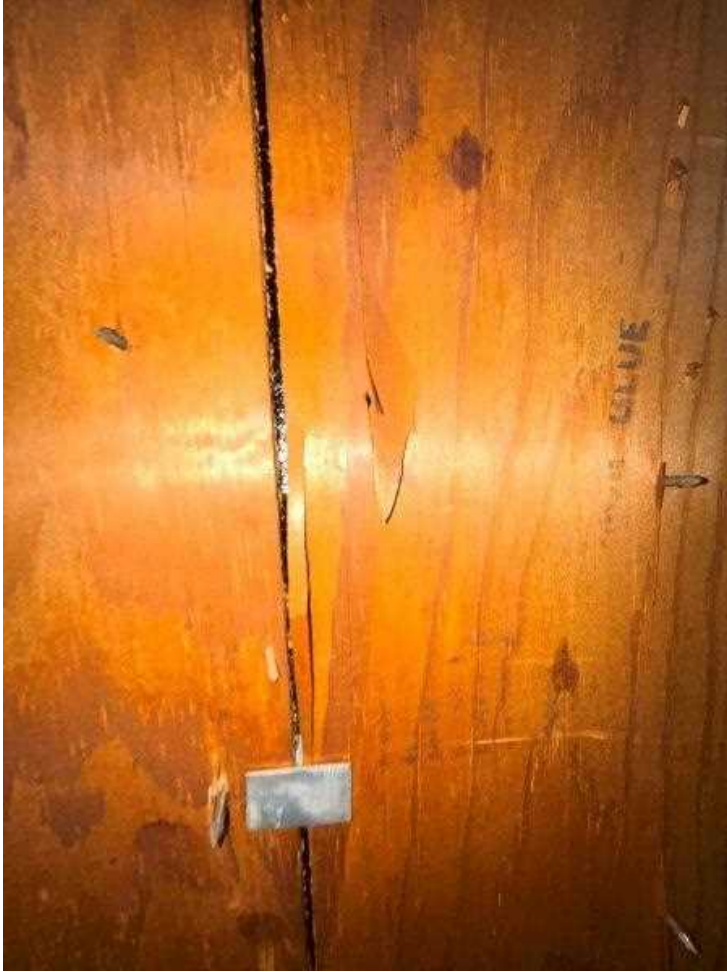
Roof Construction

- 3. Roof Deck Attachment:** **Level C**  
Comments: Inspection verified 1/2" plywood roof deck attached with 8d nails at a minimum 6" on the edge & 6" in the field.

- 4. Roof to Wall Attachment:** **Clips**  
Comments: Inspection verified embedded straps fastened with a minimum of three nails.
- 5. Roof Geometry:** **Hip Roof**  
Comments: Inspection verified a hip roof shape.

- 6. SWR:** **Yes**  
Comments: SWR was verified at time of inspection. The Secondary Water Resistance verified is a self-adhering peel and stick.
- 7. Opening Protection:** **None or Some Glazed Openings**  
Comments: No opening protection verified at the time of inspection.
