Windstorm Mitigation Report (OIR-B1-1802)

Eastwood Shores Condominium No. 4 Association, Inc.

1853 Bough Ave, Units A-D

As of 9/7/2023 | FPAT File# MIT2218498

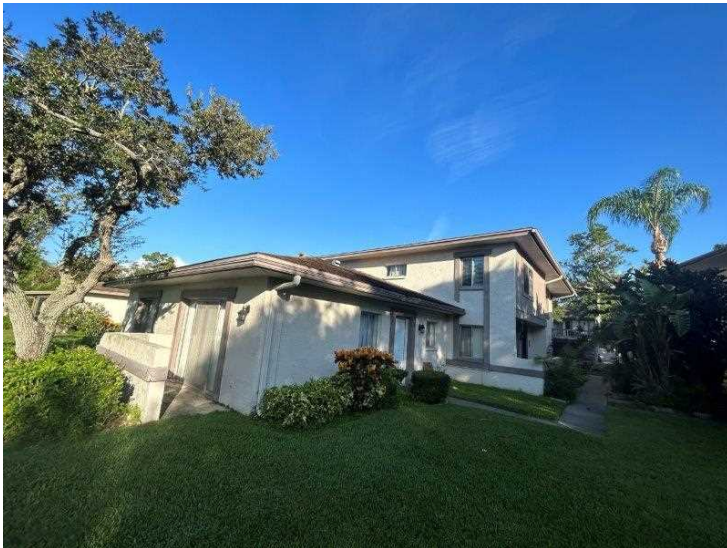
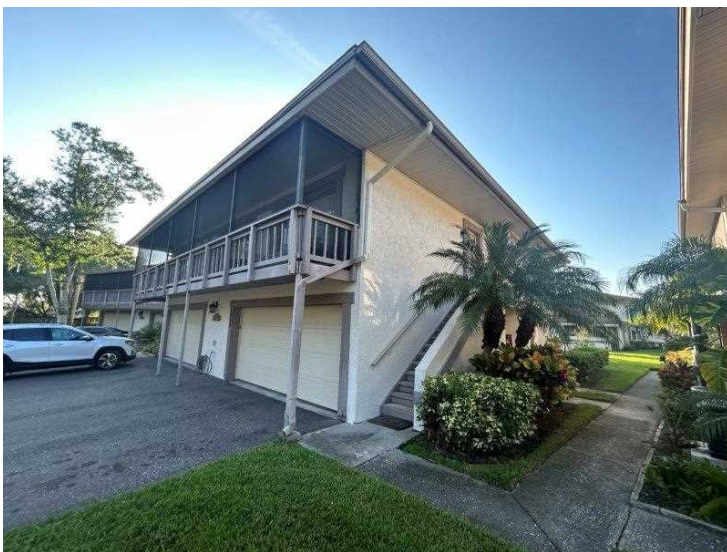
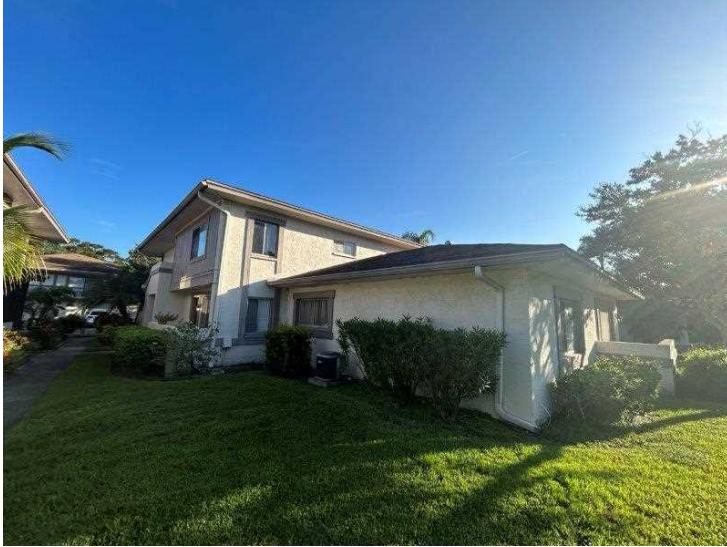
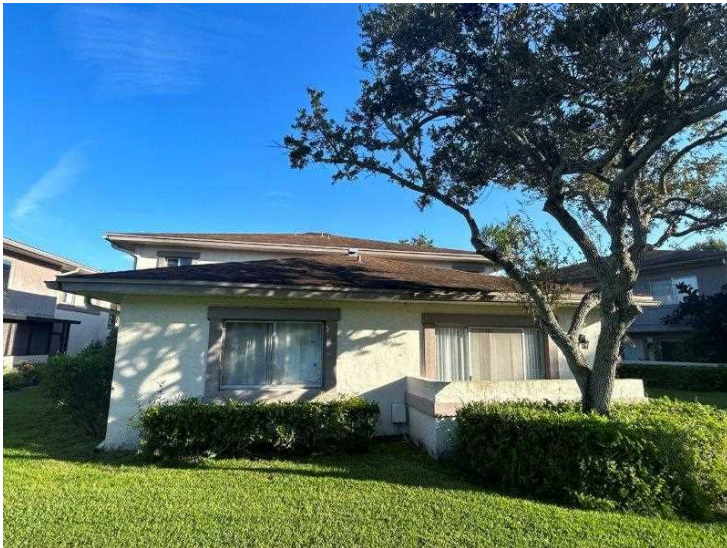
Exterior Elevation

- 4. Roof to Wall Attachment:** **Toe Nails**
Comments: Inspection verified embedded straps fastened with less than three nails.
- 5. Roof Geometry:** **Hip Roof**
Comments: Inspection verified a hip roof shape.

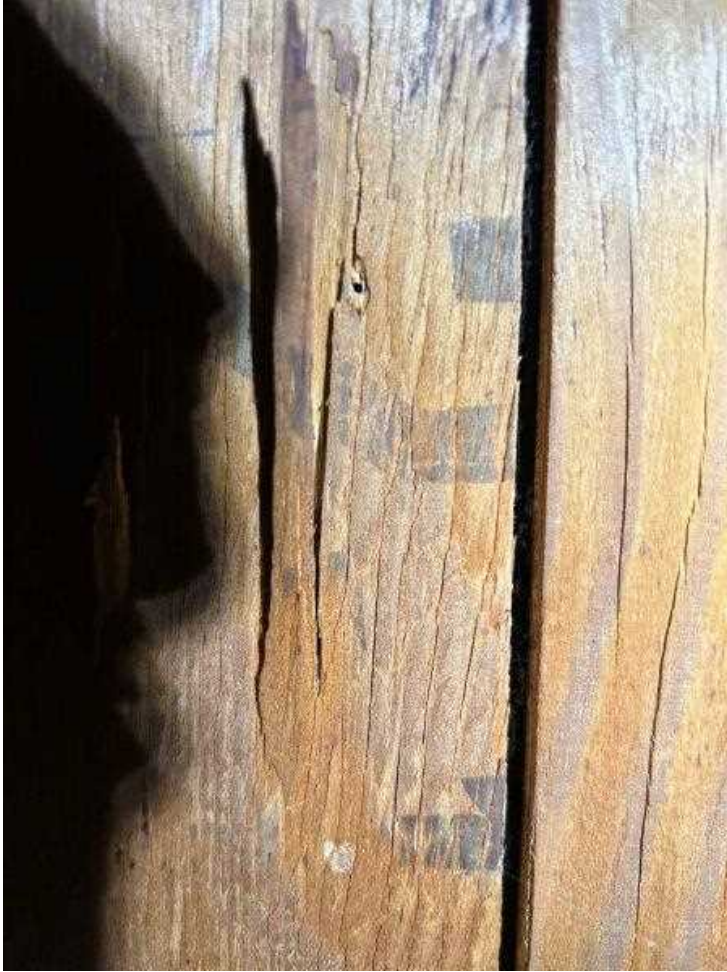
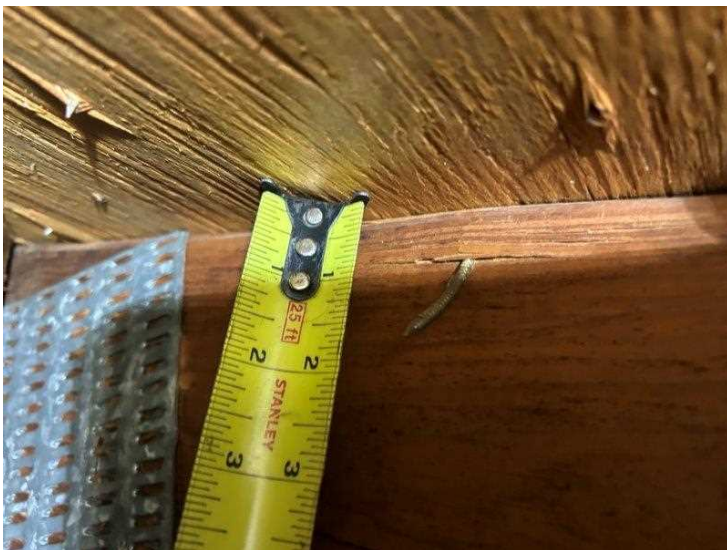
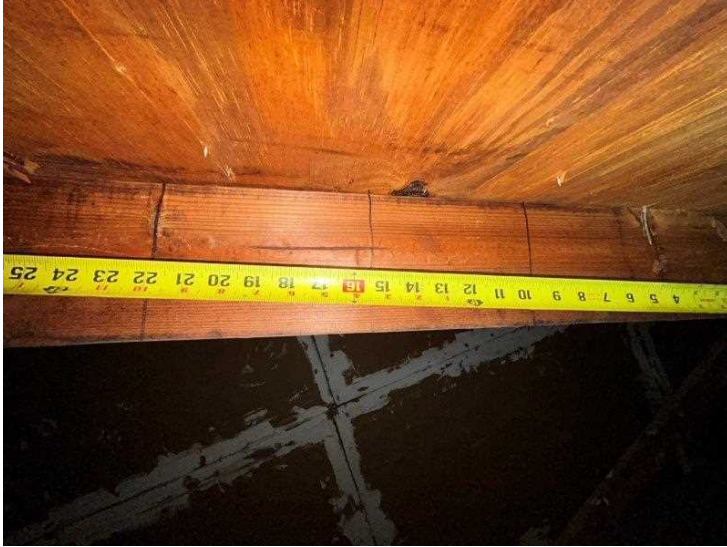
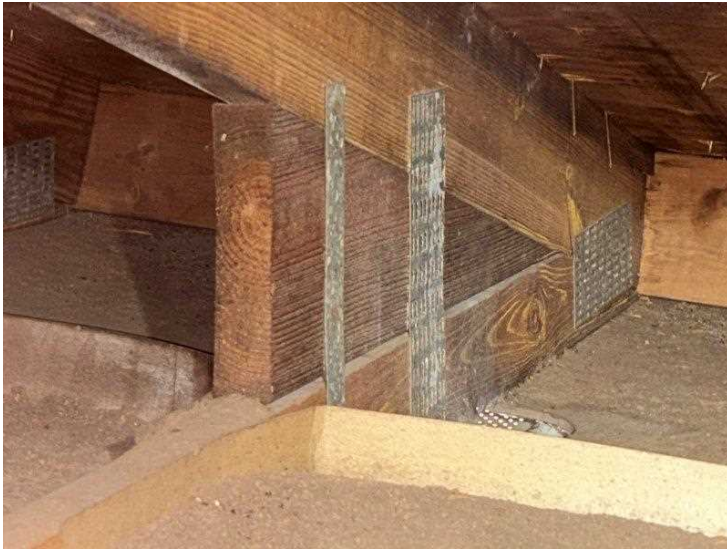
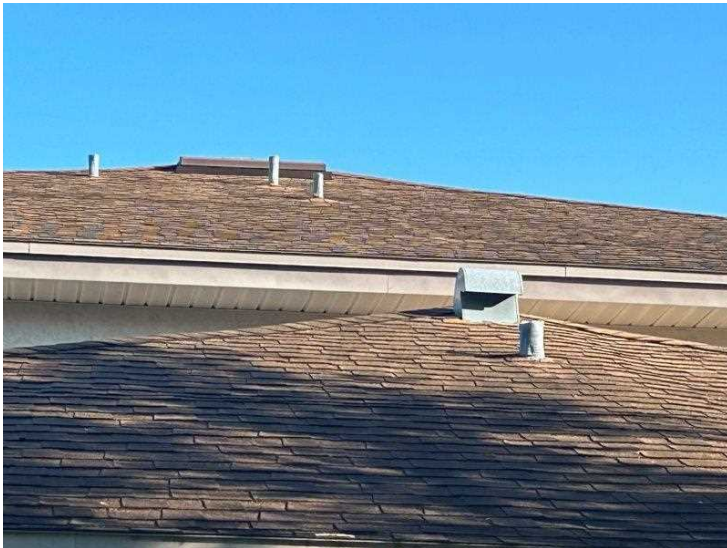
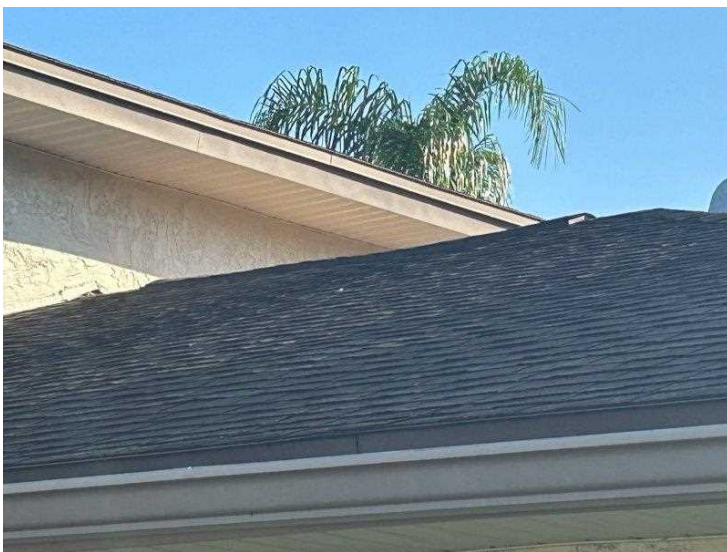
Roof Construction

- 3. Roof Deck Attachment:** **Level C**
Comments: Inspection verified 1/2" plywood roof deck attached with 8d nails at a minimum 6" on the edge & 6" in the field.

- 6. SWR:** **Yes**
Comments: SWR was verified at time of inspection. The Secondary Water Resistance verified is a self-adhering peel and stick.
- 7. Opening Protection:** **None or Some Glazed Openings**
Comments: No opening protection verified at the time of inspection.
