## Windstorm Mitigation Report (OIR-B1-1802)

Eastwood Shores Condominium No. 4 Association, Inc.

1857 Bough Ave, Units A-D

As of 9/7/2023 | FPAT File# MIT2218498

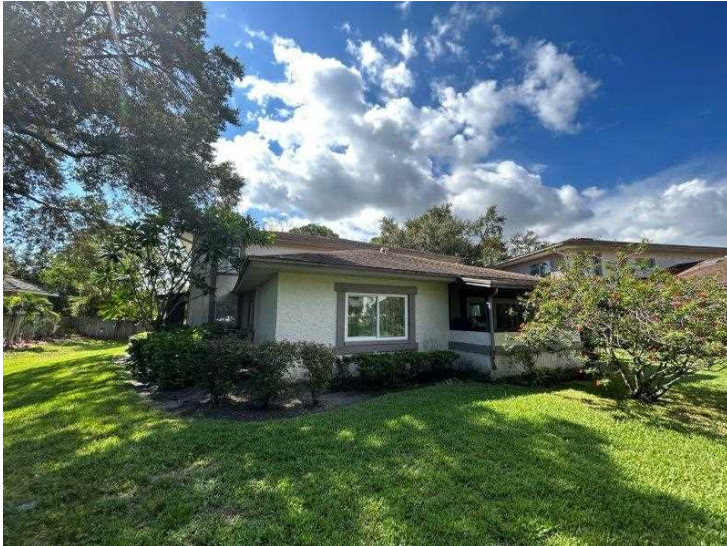
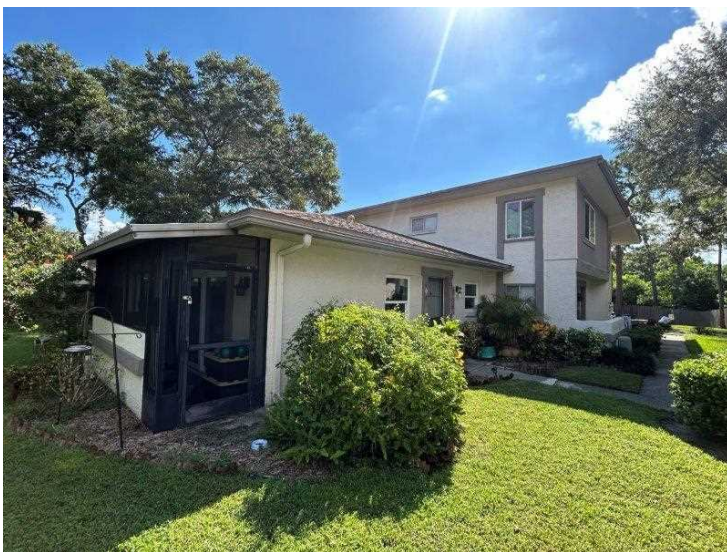
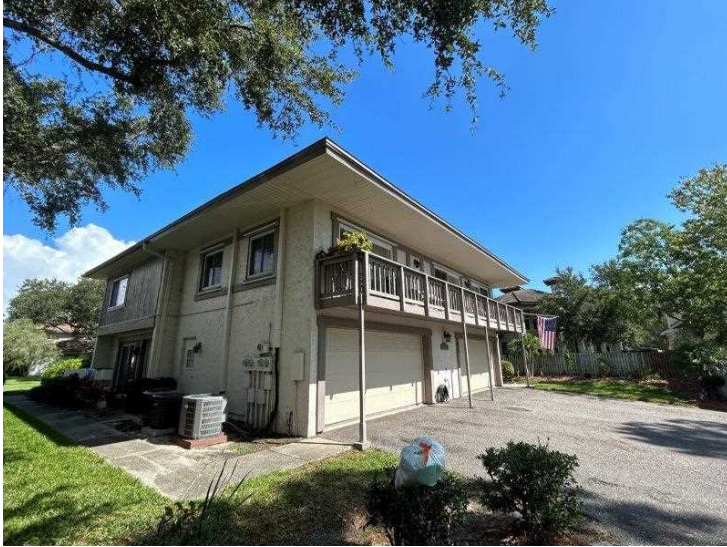
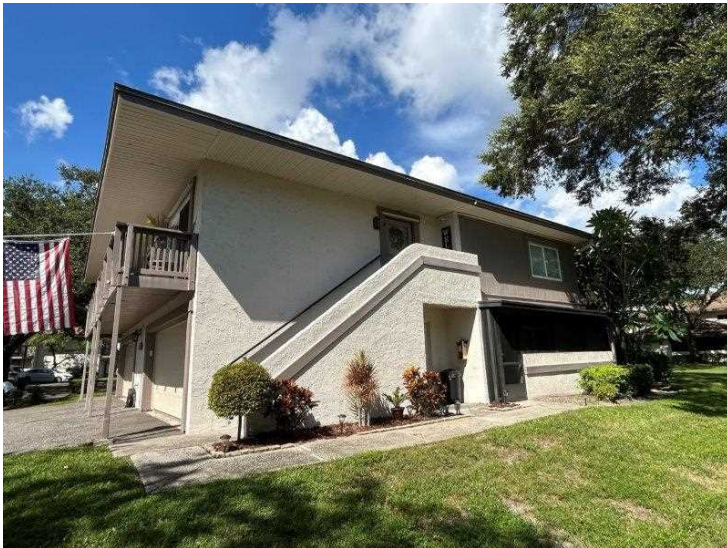
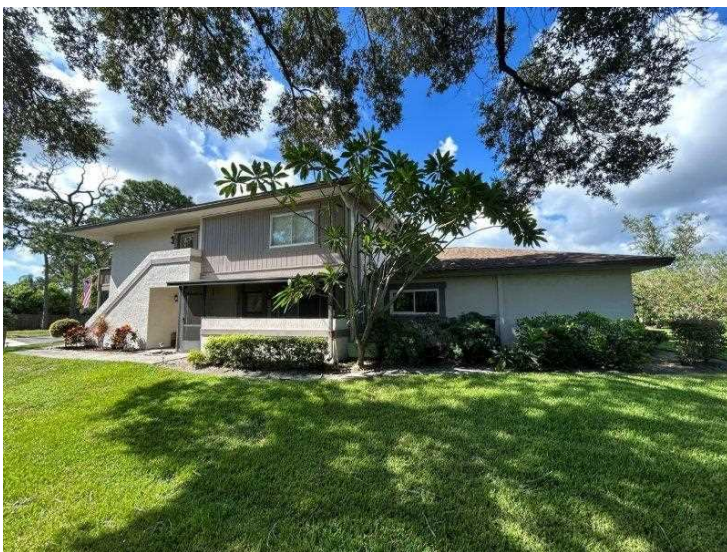
Exterior Elevation

- 4. Roof to Wall Attachment:** **Toe Nails**  
Comments: Inspection verified embedded straps fastened with less than three nails.
- 5. Roof Geometry:** **Hip Roof**  
Comments: Inspection verified a hip roof shape.

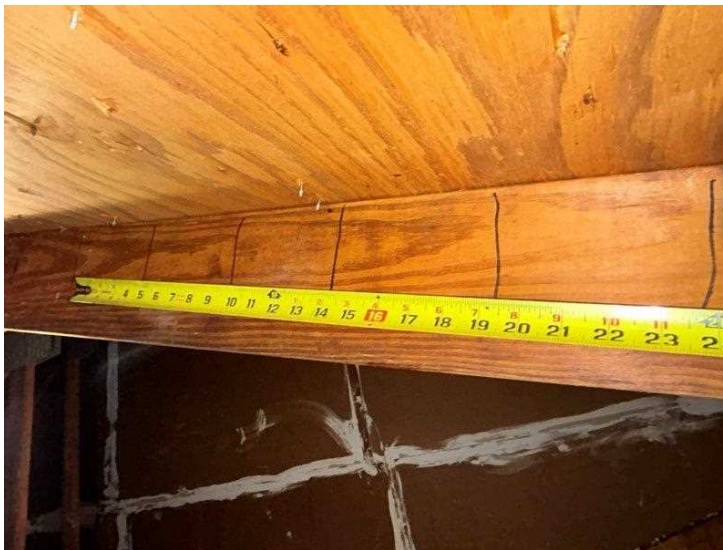
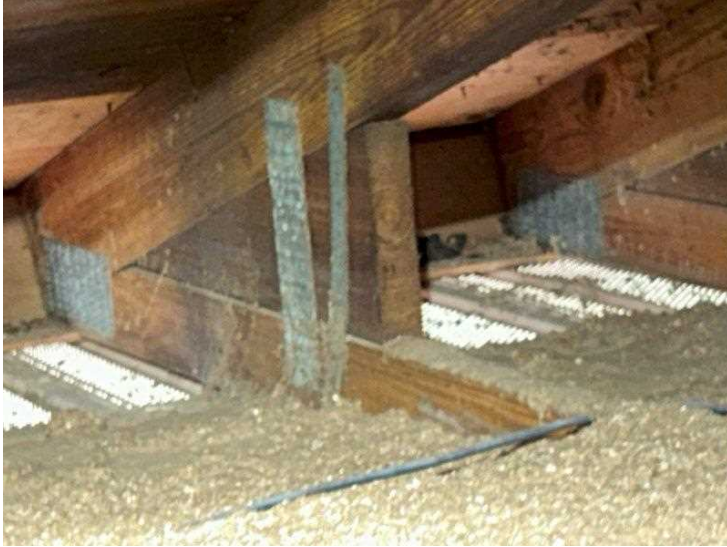
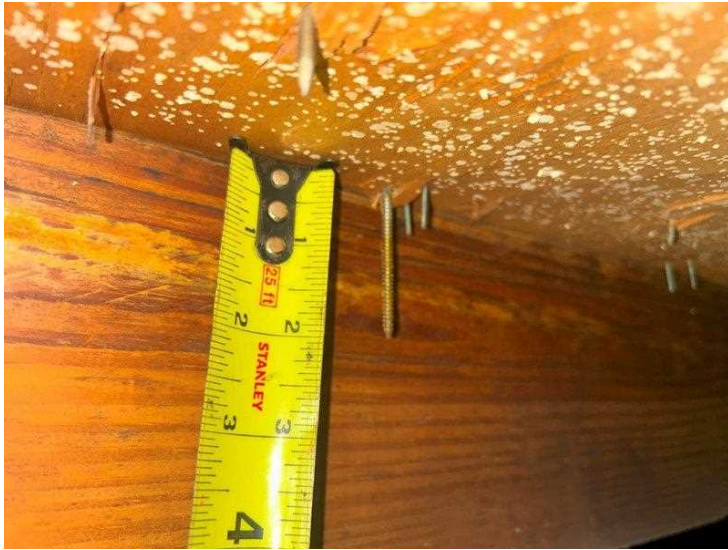
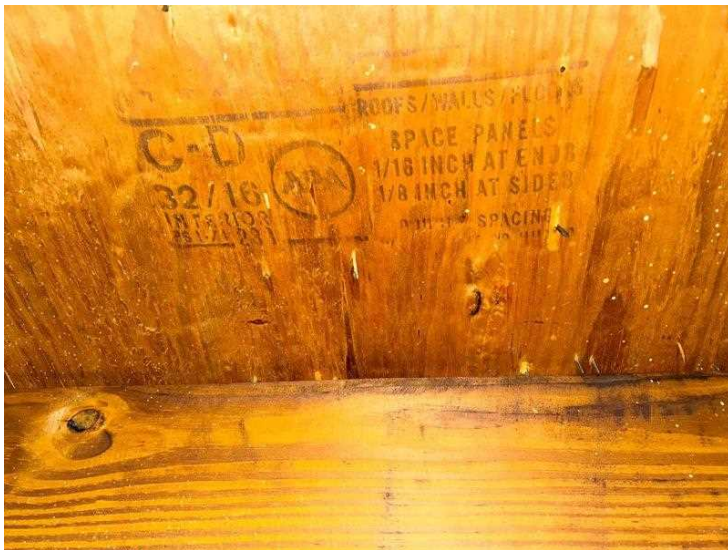
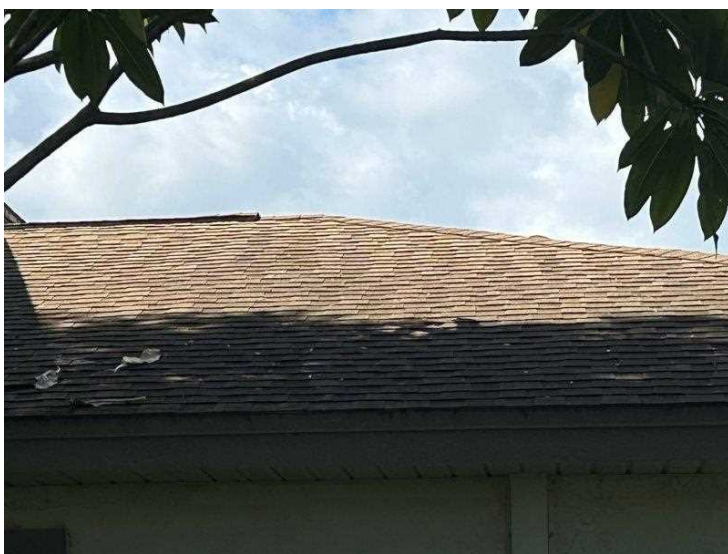
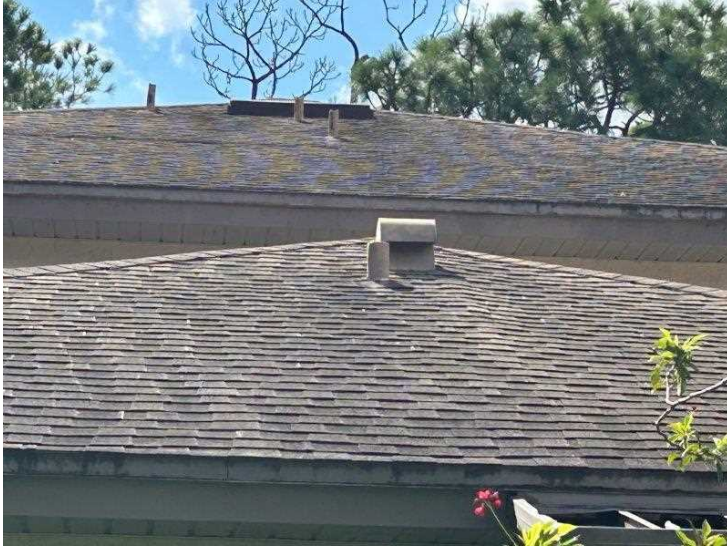
## Roof Construction

- 3. Roof Deck Attachment:** **Level C**  
Comments: Inspection verified 1/2" plywood roof deck attached with 8d nails at a minimum 6" on the edge & 6" in the field.
