## Windstorm Mitigation Report (OIR-B1-1802)

Eastwood Shores Condominium No. 4 Association, Inc.

1859 Bough Ave, Units A-D

As of 9/7/2023 | FPAT File# MIT2218498

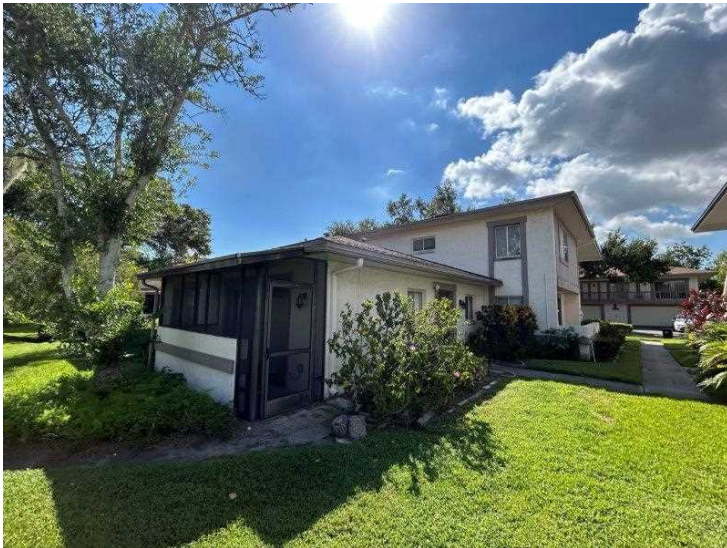
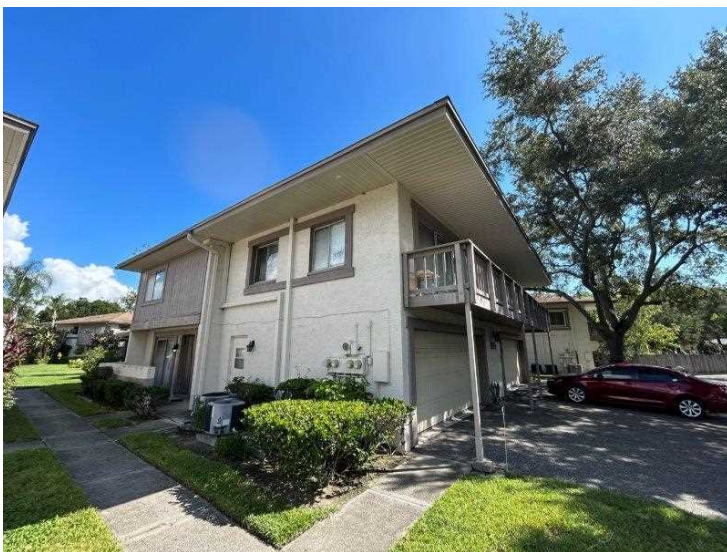
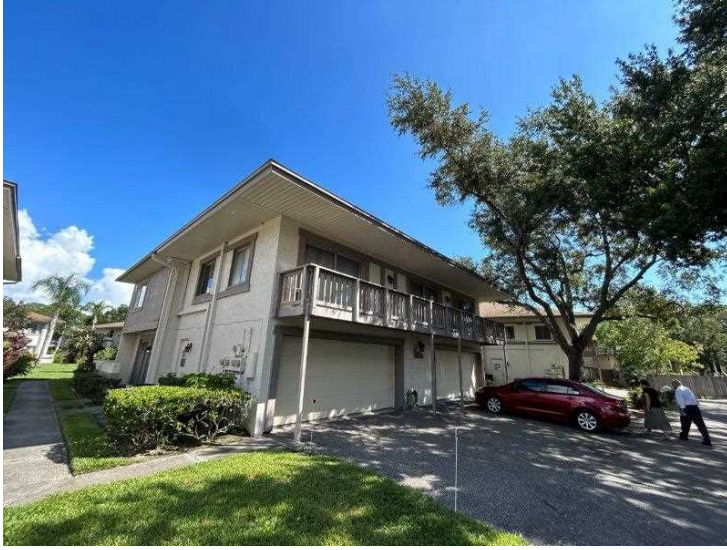
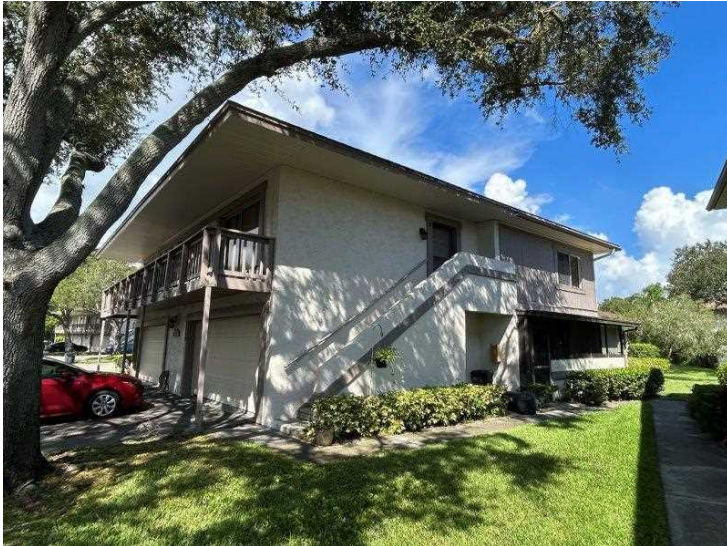
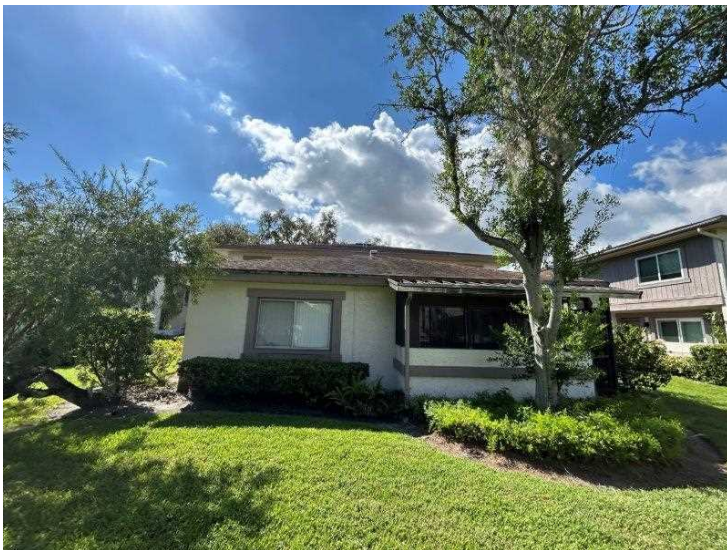
Exterior Elevation

- 4. Roof to Wall Attachment:** **Toe Nails**  
Comments: Inspection verified embedded straps fastened with less than three nails.
- 5. Roof Geometry:** **Hip Roof**  
Comments: Inspection verified a hip roof shape.

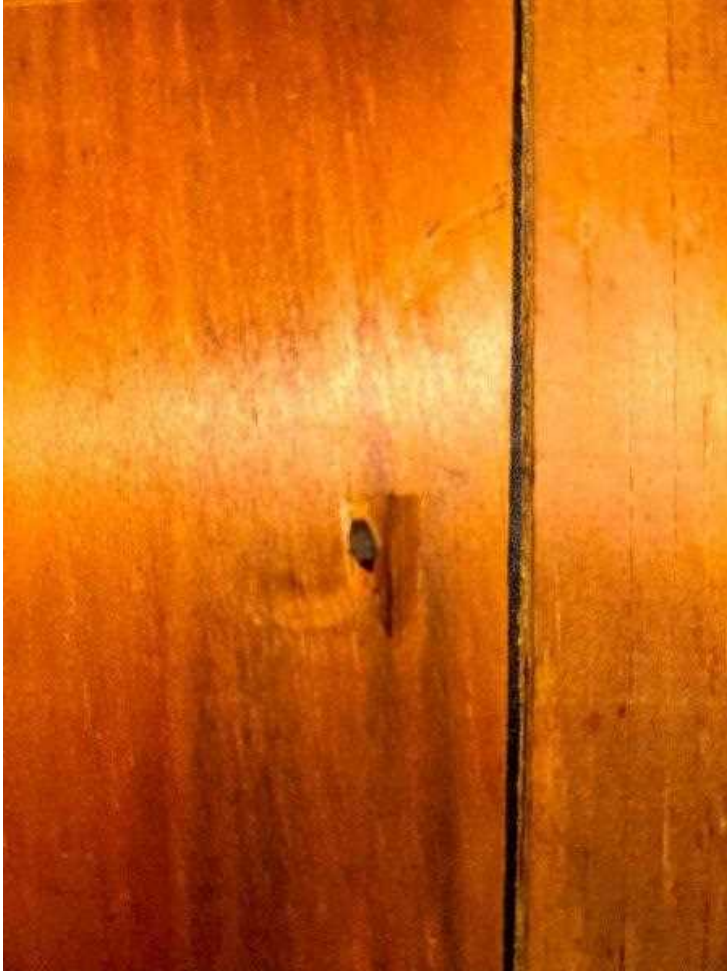
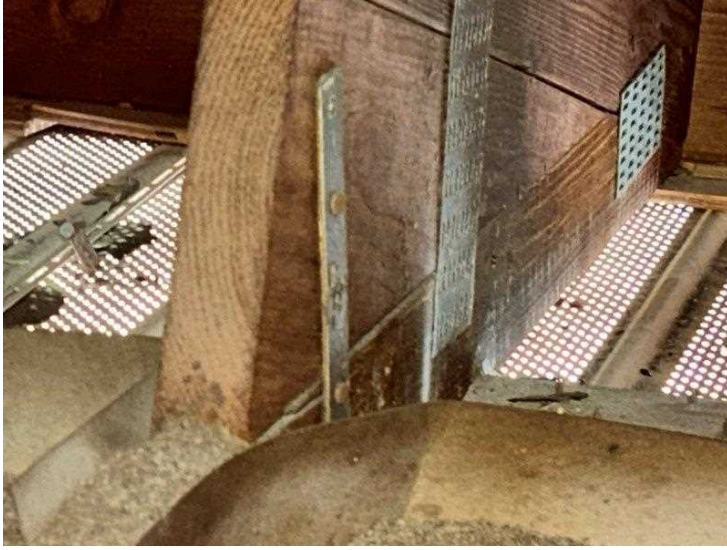
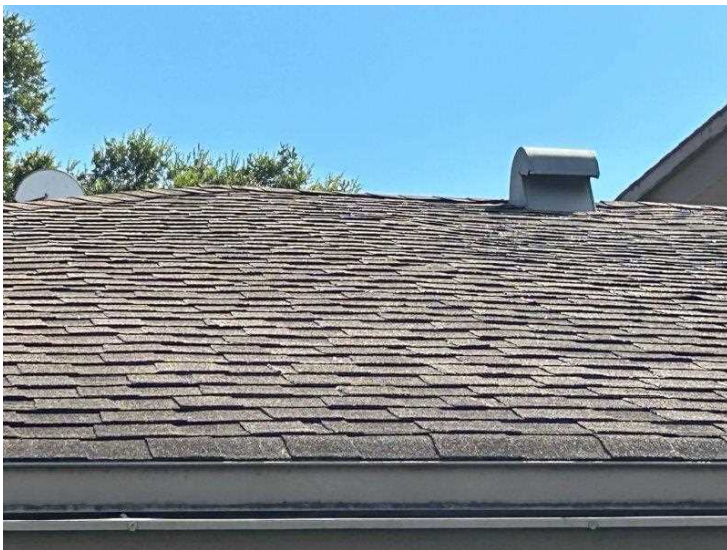
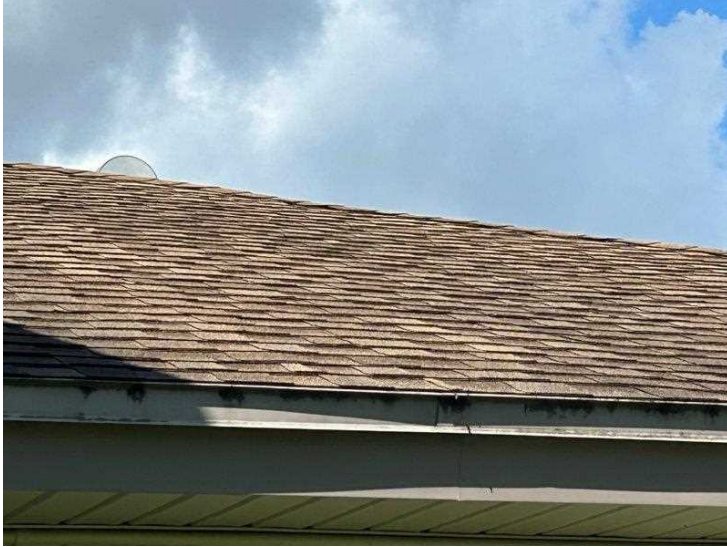
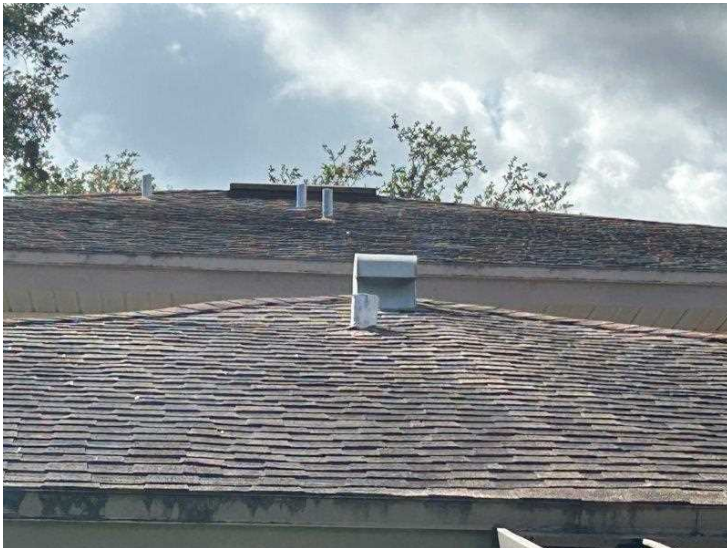
Roof Construction

- 3. Roof Deck Attachment:** **Level A**  
Comments: Inspection verified 1/2" plywood roof deck attached with staples at a minimum of 6" on the edge & 12" in the field.
