## Windstorm Mitigation Report (OIR-B1-1802)

Eastwood Shores Condominium No. 4 Association, Inc.

1861 Bough Ave, Units A-D

As of 9/7/2023 | FPAT File# MIT2218498

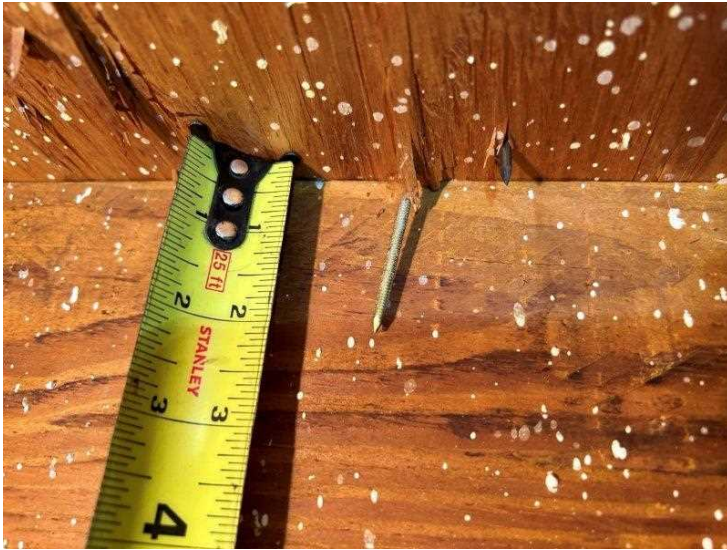
Roof Construction

- 3. Roof Deck Attachment:** **Level C**  
Comments: Inspection verified 1/2" plywood roof deck attached with 8d nails at a minimum 6" on the edge & 6" in the field.

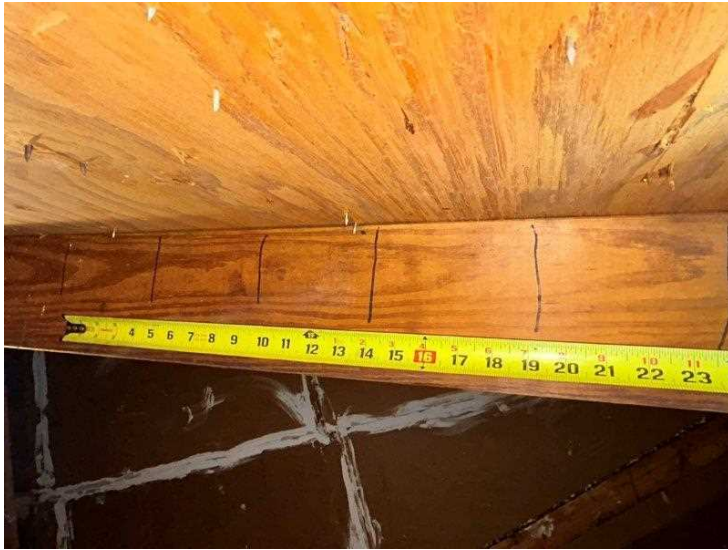
Roof Construction

- 4. Roof to Wall Attachment:** **Toe Nails**  
Comments: Inspection verified hurricane clips fastened with two nails.
- 5. Roof Geometry:** **Hip Roof**  
Comments: Inspection verified a hip roof shape.
