Windstorm Mitigation Report (OIR-B1-1802)

Eastwood Shores Condominium No. 4 Association, Inc.

1865 Bough Ave, Units A-D

As of 9/7/2023 | FPAT File# MIT2218498

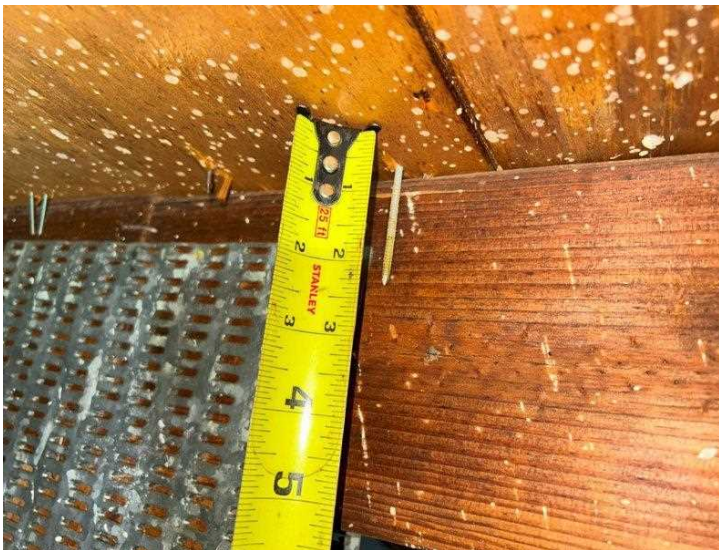
Roof Construction

- 3. Roof Deck Attachment:** **Level C**
Comments: Inspection verified 1/2" plywood roof deck attached with 8d nails at a minimum 6" on the edge & 6" in the field.

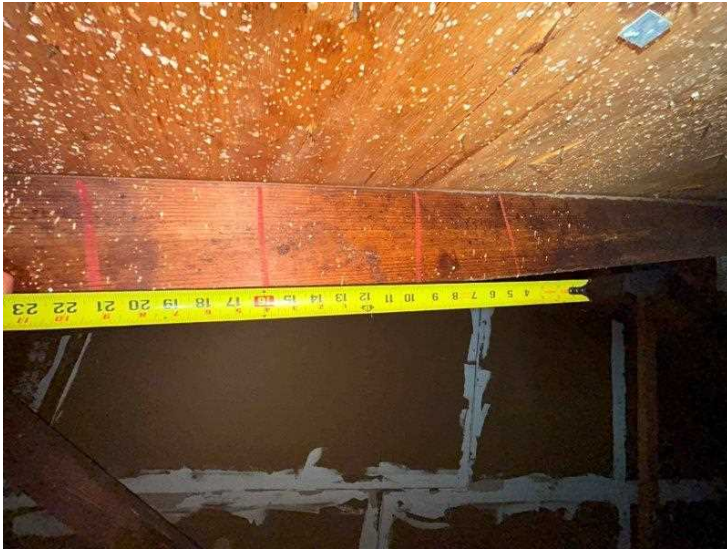
Roof Construction

- 4. Roof to Wall Attachment:** **Toe Nails**
Comments: Inspection verified embedded straps fastened with less than three nails.
- 5. Roof Geometry:** **Hip Roof**
Comments: Inspection verified a hip roof shape.

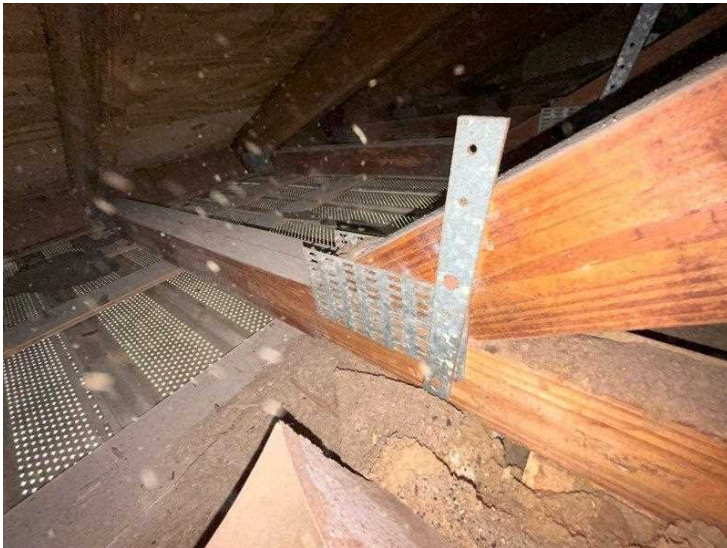
Roof Construction

- 6. SWR:** **Yes**
Comments: SWR was verified at time of inspection. The Secondary Water Resistance verified is a self-adhering peel and stick.
- 7. Opening Protection:** **None or Some Glazed Openings**
Comments: No opening protection verified at the time of inspection.
