Windstorm Mitigation Report (OIR-B1-1802)

Eastwood Shores Condominium No. 4 Association, Inc.

3000 Bough Ave, Units A-D

As of 9/7/2023 | FPAT File# MIT2218498

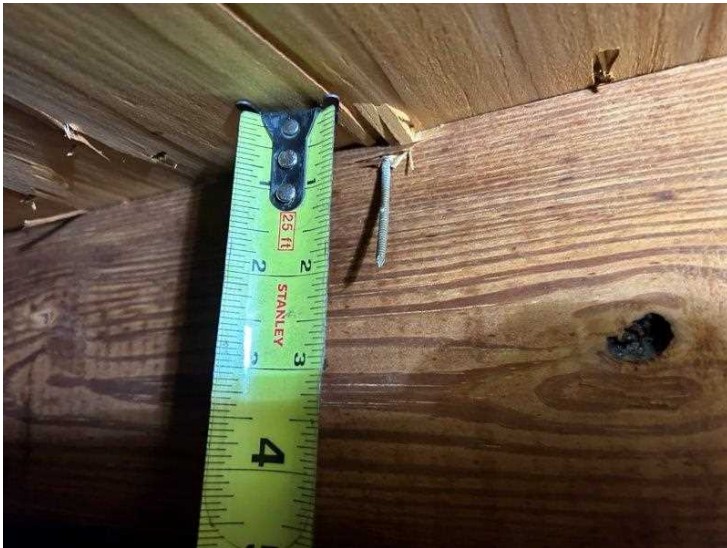
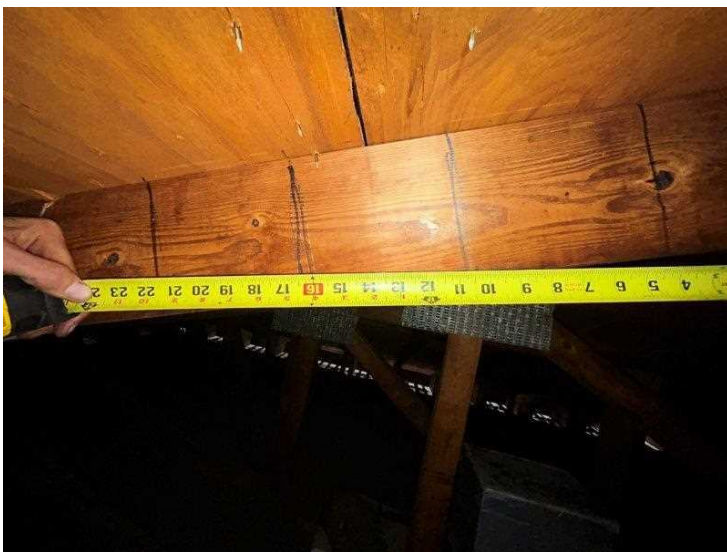
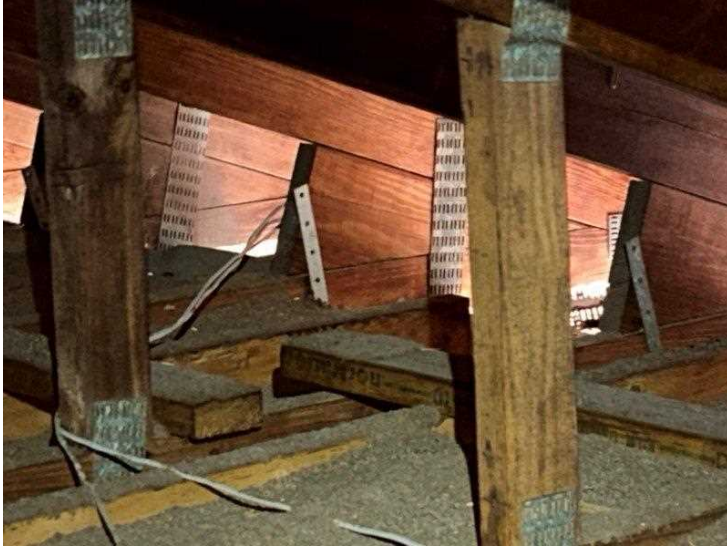
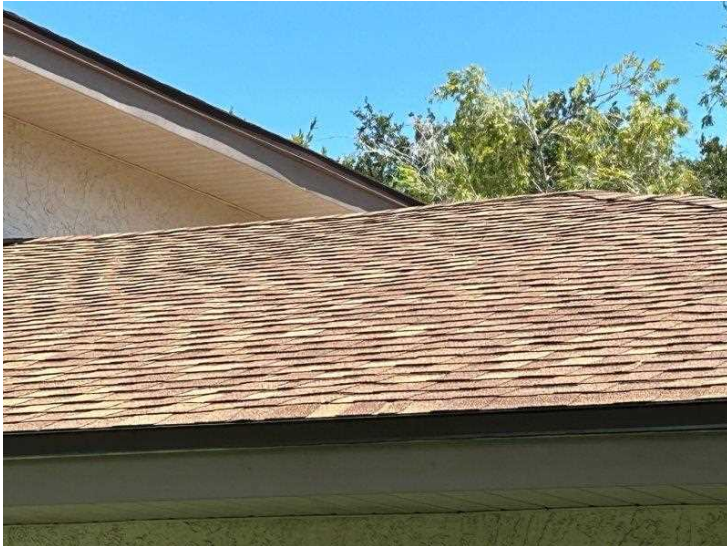
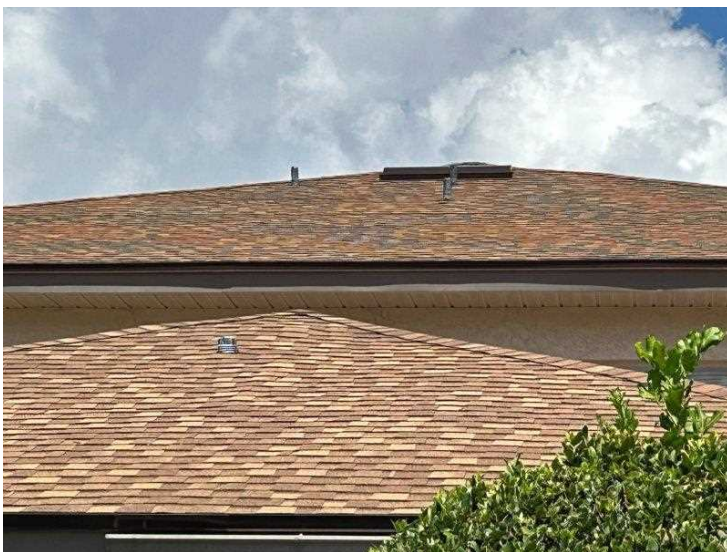
Roof Construction

- 3. Roof Deck Attachment:** **Level C**
Comments: Inspection verified 1/2" plywood roof deck attached with 8d nails at a minimum 6" on the edge & 6" in the field.

- 4. Roof to Wall Attachment:** **Clips**
Comments: Inspection verified embedded straps fastened with a minimum of three nails.
- 5. Roof Geometry:** **Hip Roof**
Comments: Inspection verified a hip roof shape.

- 6. SWR:** **Yes**
Comments: SWR was verified at time of inspection. The Secondary Water Resistance verified is a self-adhering peel and stick.
- 7. Opening Protection:** **None or Some Glazed Openings**
Comments: No opening protection verified at the time of inspection.
