Windstorm Mitigation Report (OIR-B1-1802)

Eastwood Shores Condominium No. 4 Association, Inc.

3004 Bough Ave, Units A-D

As of 9/7/2023 | FPAT File# MIT2218498

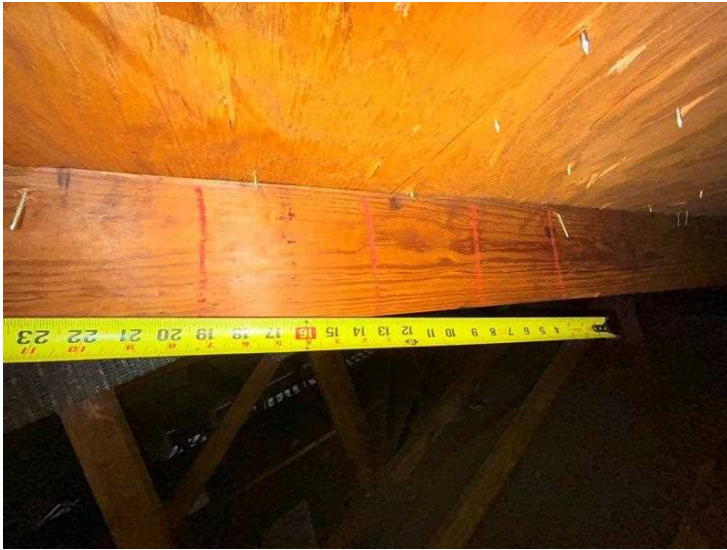
Roof Construction

- 3. Roof Deck Attachment:** **Level C**
Comments: Inspection verified 1/2" plywood roof deck attached with 8d nails at a minimum 6" on the edge & 6" in the field.
