Uniform Mitigation Verification Inspection Form

Inspection Date: 9/23/11		
Owner Information		
Owner Name: Eastwood Shores 4		Contact Person:
Address: 1865 Bough AVE		Home Phone:
City: Clearwater	Zip: 33760	Work Phone:
County: Pinellas		Cell Phone:
Insurance Company:		Policy #:
Year of Home:	# of Stories: two	Email:

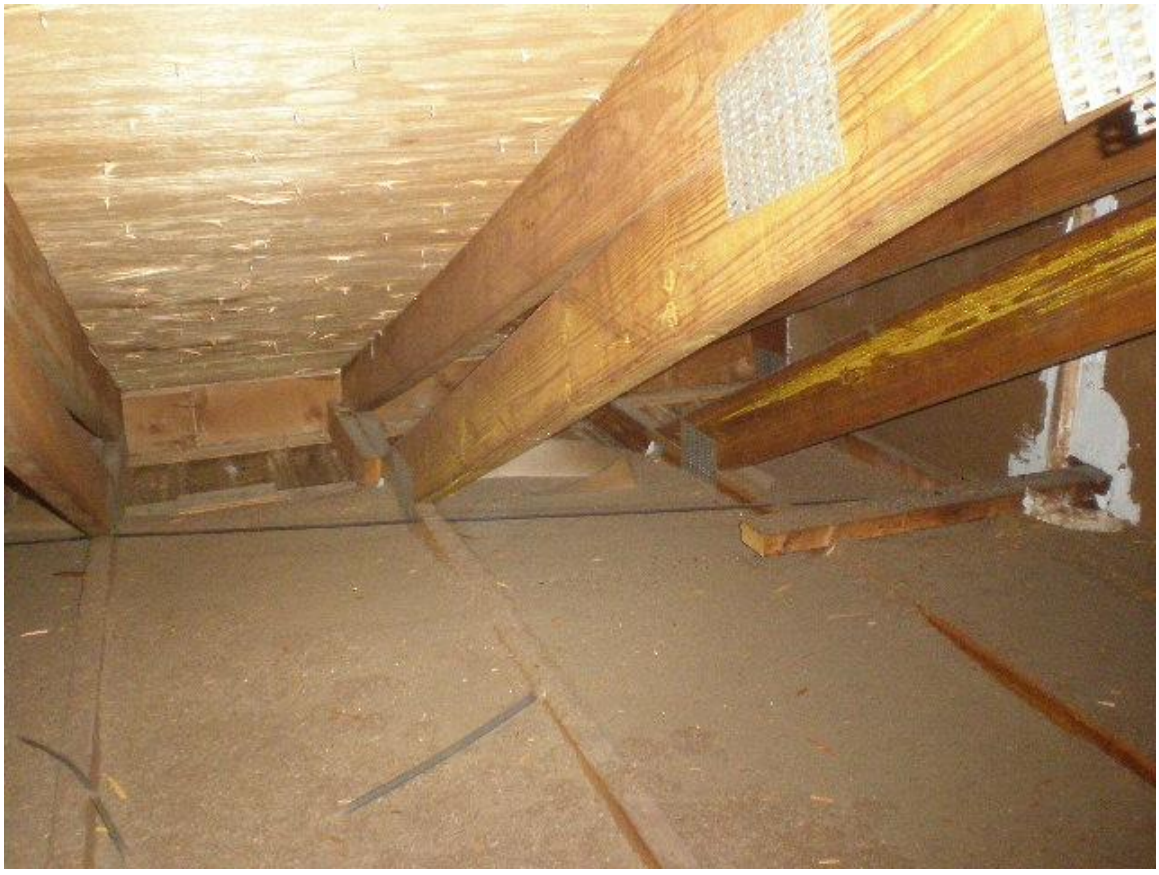
Roof deck 8d nails 6x6
